# PROJECT REPRESENTATIVE'S DAILY REPORT

Pg. 1  
Report No. 114  
Date: 2015-02-03  
Day: Tuesday

**Project:** Renovation and Addition to Tewksbury Town Hall

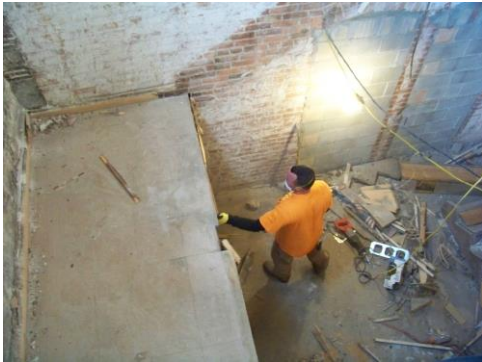
Photo showing the stair demolition being completed.

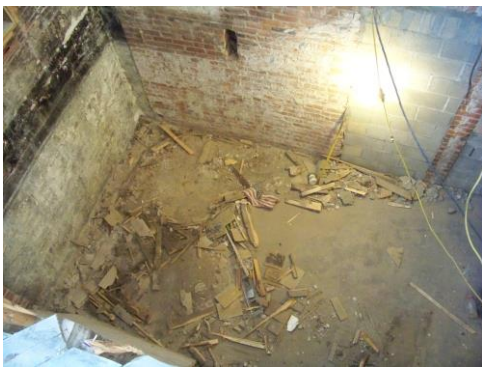
Photo showing stairs completely demolished and removed.

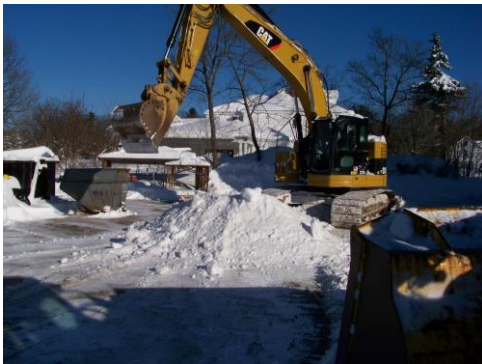
Photo showing snow removal operations in progress.

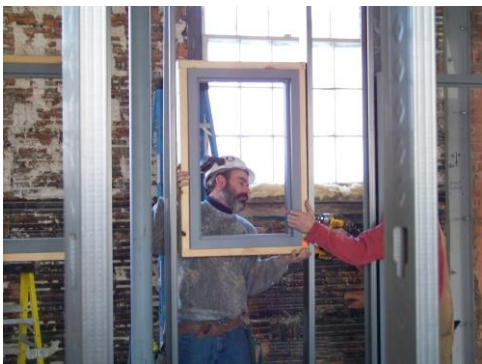
Photo showing carpenter installing window frames in stud wall for the north corridor on the 1<sup>st</sup> floor.

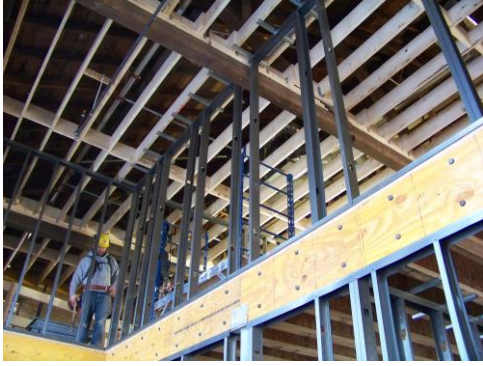
Photo showing stud framing in place on the 2<sup>nd</sup> floor. This is on the north elevation.

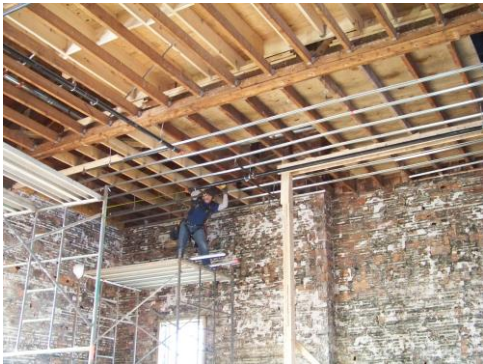
Photo showing the ceiling furring and tracks for the platform located at the west end of the meeting hall.

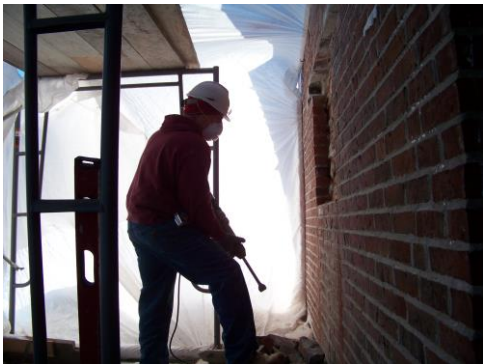
Photo showing mason removing masonry to make opening for new window. This is on the north elevation, 2<sup>nd</sup> floor.

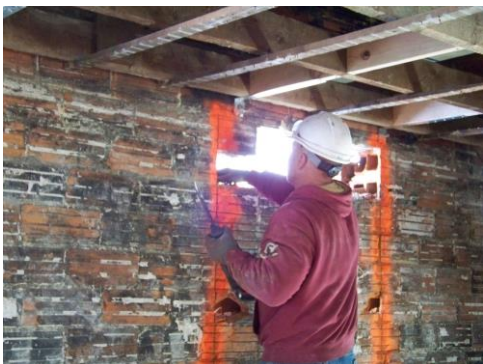
Photo showing the mason working on the interior for the new window opening.

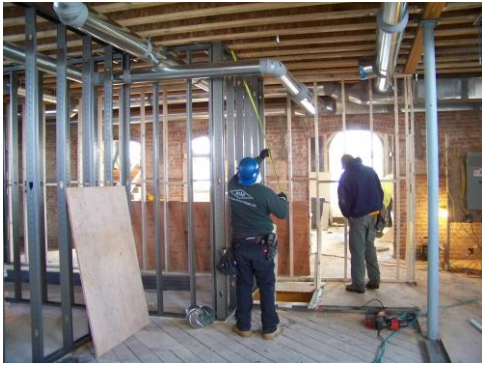
Photo showing HVAC and plumbing coordinating layout of their respective equipment and materials.

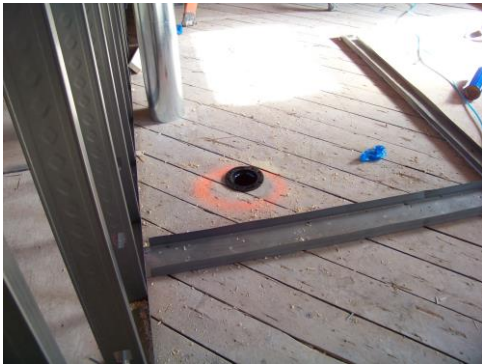
Photo showing drain for bathroom in place on 1<sup>st</sup> floor.

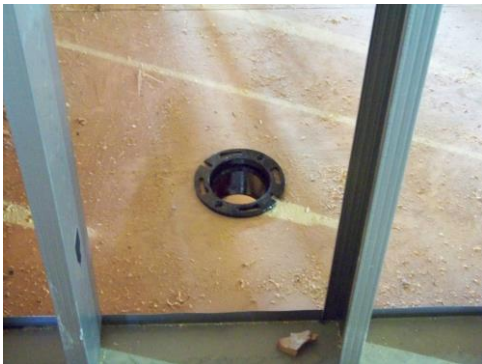
Photo showing toilet drain in place for 2<sup>nd</sup> flr.

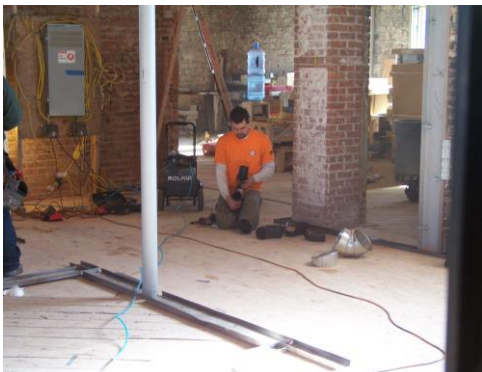
Photo showing plumber prepping pieces to install.

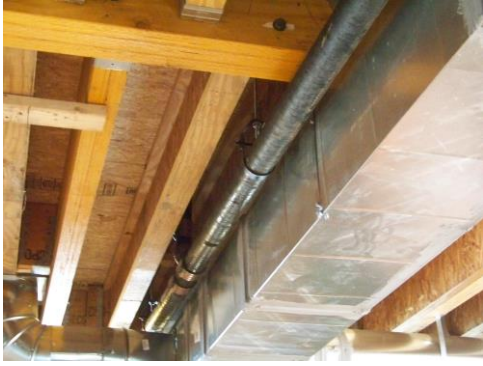
Photo showing some of the piping in place.

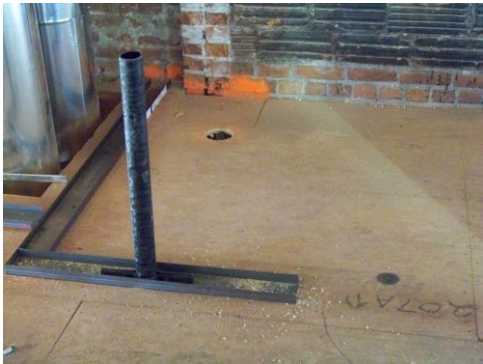
Photo showing vent pipe in place at the janitor's closet on the 2<sup>nd</sup> floor.
